Saltash Town Council

Services Committee - Budget Report - February 2018

Annual Inspection - 28 November 2016 at 14:45 Inspector: Dr. Jody Chilton RPII Annual Inspector

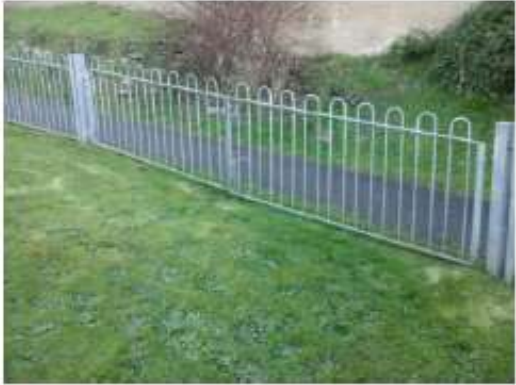
The gate is not a contrasting colour to the fencing making it difficult for users with impaired sight to distinguish it from the fence - We would recommend that the gates are painted a distinguishable colour to that of the fence

3 - Very Low Risk	
Item:	Ancillary Items - Gate - Maintenance
Manufacturer:	Unknown
Surface Type:	Grass
Equipment Compliance:	N/A
Surface Area Compliance:	N/A
Ref/Part Number:	
Total Findings:	1

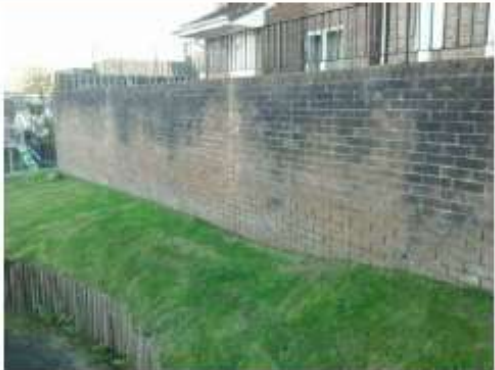
i 3 - Very Low Risk	
Item:	Ancillary Items - Brick Wall
Manufacturer:	Unknown
Surface Type:	Grass
Equipment Compliance:	N/A
Surface Area Compliance:	N/A
Ref/Part Number:	
Total Findings:	1

Finding 1 This item is satisfactory - no work required
--

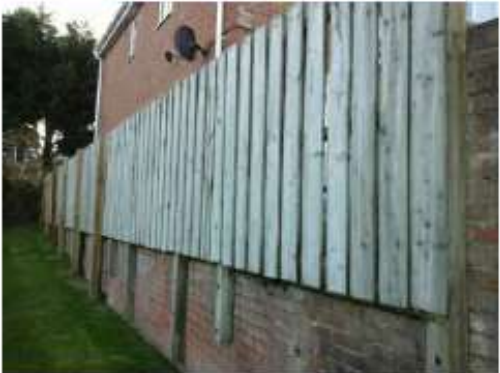
3 - Very Low Risk	
Item:	Ancillary Items - Fencing - Timber
Manufacturer:	Unknown
Surface Type:	Grass
Equipment Compliance:	N/A
Surface Area Compliance:	N/A
Ref/Part Number:	
Total Findings:	1

Finding 1
This item is satisfactory - no work required

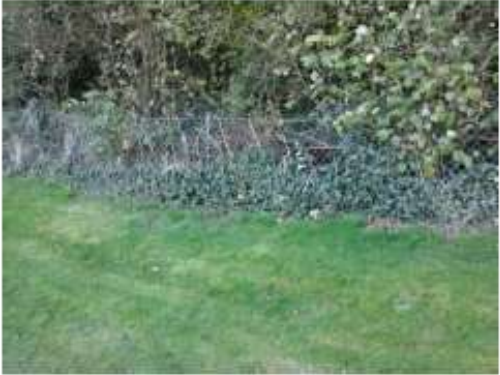
8 - Low Risk	
Item:	Ancillary Items - Fence - Chainlink
Manufacturer:	Unknown
Surface Type:	Grass
Equipment Compliance:	N/A
Surface Area Compliance:	N/A
Ref/Part Number:	
Total Findings:	3

Finding 1	Finding 2
The fence is damaged and there is an informal access to the site - Repair the fence to prevent access	There are a number of loose posts around the fence - Monitor for any further deterioration and reset as required

Finding 3
There is surface corrosion present on the posts - Consider treating and repainting the item

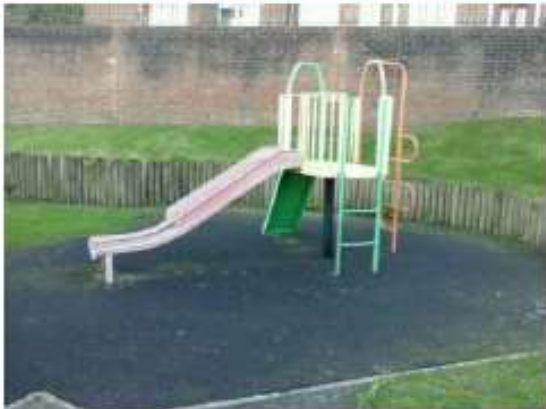
8 - Low Risk	
Item:	Activity Equipment - Multi Play (Junior)
Manufacturer:	Record RSS
Surface Type:	Wet Pour
Equipment Compliance:	No
Surface Area Compliance:	Yes
Ref/Part Number:	
Total Findings:	5

Finding 1 There are a number of dents in the slide surface - Monitor for any further deterioration and repair as required	Finding 2 There is algae or moss on the surface of the equipment - Clean and treat appropriately
Finding 3 The chain openings are in excess of the 8.6mm as recommended by BS EN 1176 - Monitor use and replace with compliant chains during next maintenance cycle.	Finding 4 There is/are finger entrapment/s in the top of the slide and the item fails to meet the requirements of BS EN 1176:2008 Part 1 4.2.7.8 Entrapment of fingers - Monitor use
Finding 5 There is surface corrosion present on the item - Consider treating and repainting the item

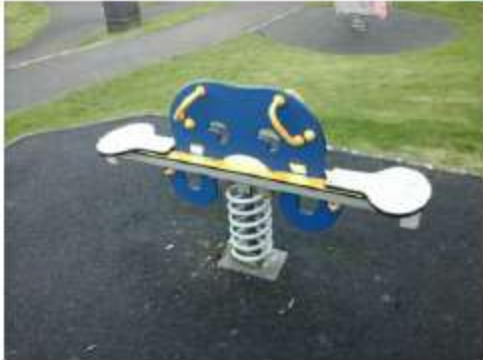
8 - Low Risk	
Item:	Rocking Equipment - Spring See-Saw
Manufacturer:	Ledon
Surface Type:	Wet Pour
Equipment Compliance:	Yes
Surface Area Compliance:	Yes
Ref/Part Number:	
Total Findings:	2

Finding 1	Finding 2
The safety surface under or around this unit has been damaged - Monitor for any further deterioration and repair as required	The paintwork on the spring has been damaged or worn exposing the metal underneath which is rusting - Treat any rusting components and repaint

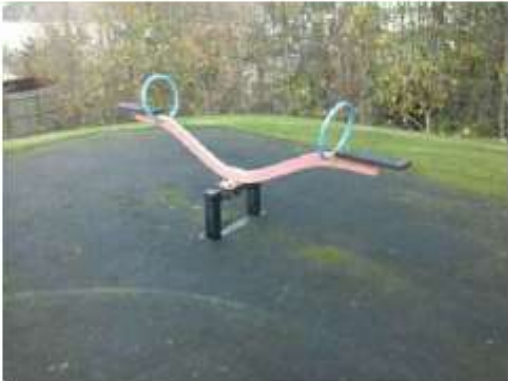
i 8 - Low Risk	
Item:	Rocking Equipment - See Saw
Manufacturer:	Record RSS
Surface Type:	Wet Pour
Equipment Compliance:	Yes
Surface Area Compliance:	Yes
Ref/Part Number:	
Total Findings:	4

Finding 1	Finding 2
The mounting fixings are corroded - Replace all affected fixings	The seat has minor damage or wear - Monitor for any further deterioration and replace as required
Finding 3	Finding 4
There is surface corrosion present on the item - Consider treating and repainting the item	There is algae or moss on the surface of the equipment - Clean and treat appropriately

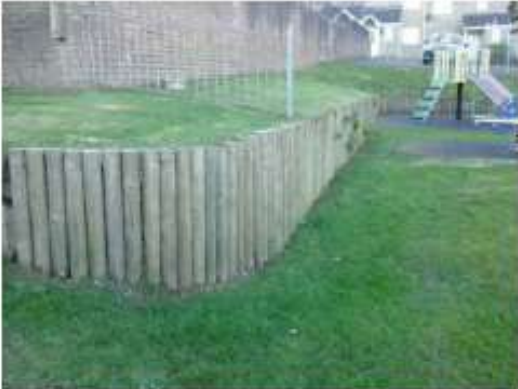
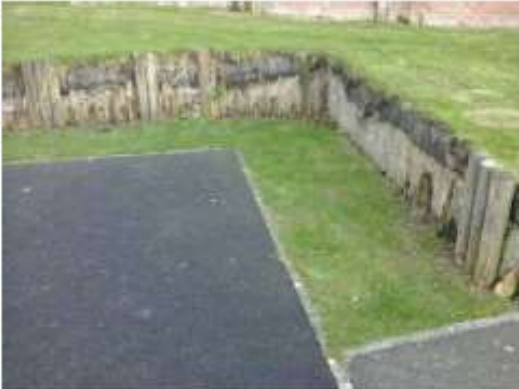
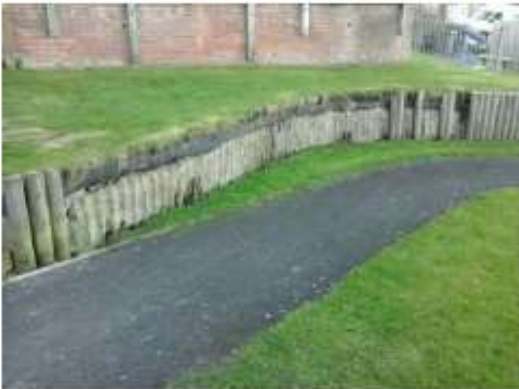
8 - Low Risk (Finding 1)			
Item:	Ancillary Items - Palisade Logs	Risk Level:	L - Low Risk
Manufacturer:	Unknown	Surface:	Grass

Finding:	There are a large number of logs missing from site		Action: Replace as required

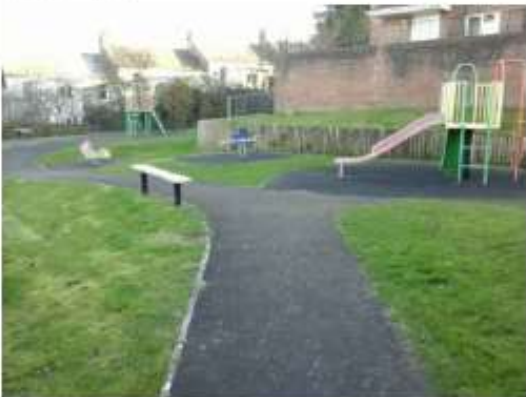
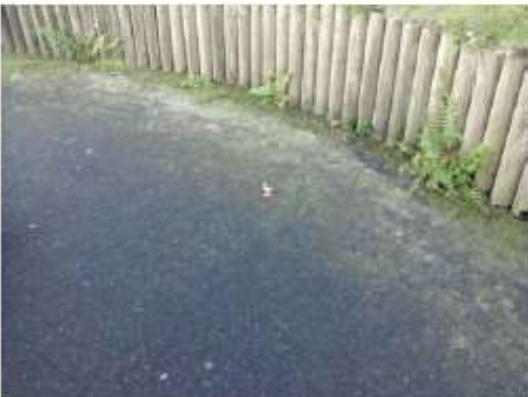
8 - Low Risk (Finding 2)			
Item:	Ancillary Items - Site General	Risk Level:	L - Low Risk
Manufacturer:	Unknown	Surface:	Grass

Finding: There is algae or moss growth on the wetpour surfaces throughout the site resulting in slippery conditions		Action: Clean and treat appropriately

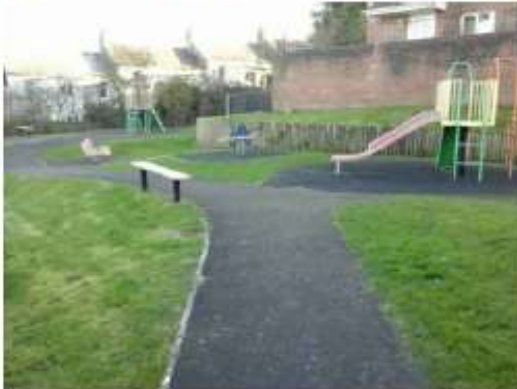
8 - Low Risk (Finding 3)

Item:	Ancillary Items - Site General	Risk Level:	L - Low Risk
Manufacturer:	Unknown	Surface:	Grass

Finding: There are trip hazards at the edges of the surfaces throughout the site

Action: Reinstate surrounding surface levels to remove the trip points

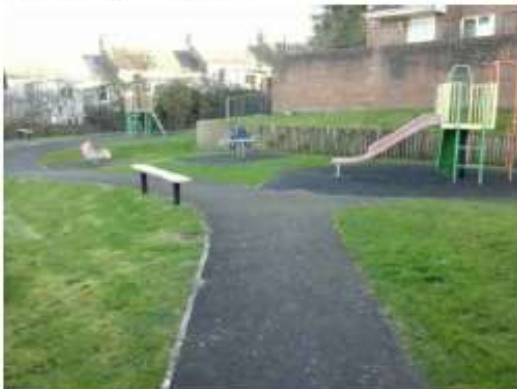
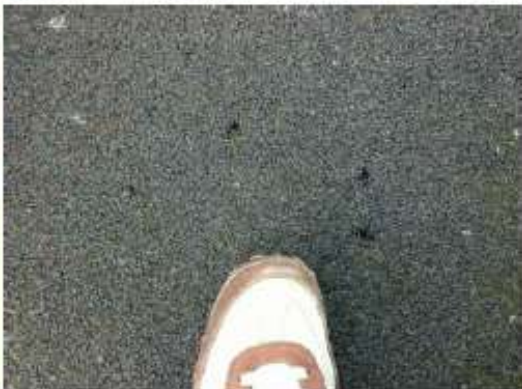
8 - Low Risk (Finding 4)

Item:	Ancillary Items - Site General	Risk Level:	L - Low Risk
Manufacturer:	Unknown	Surface:	Grass

Finding: The safety surfaces throughout the site are beginning to wear

Action: Monitor for any further deterioration and repair as required

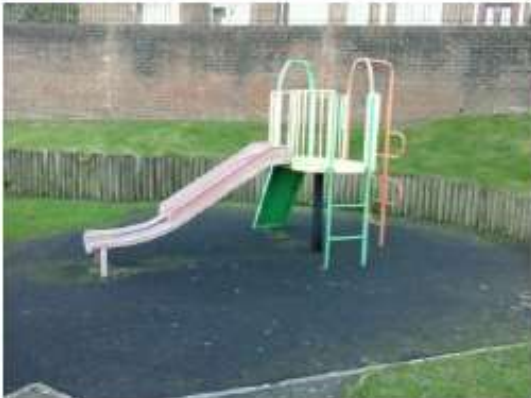
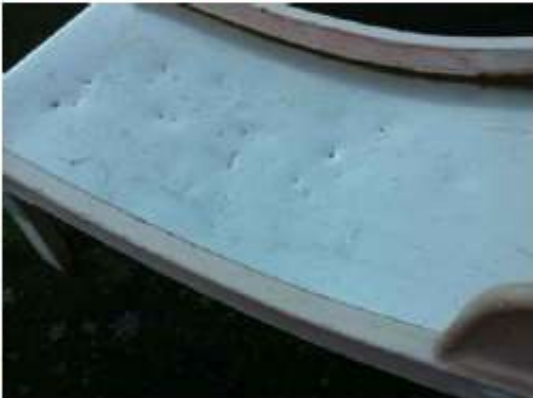
6 - Low Risk (Finding 1)			
Item:	Activity Equipment - Multi Play (Junior)	Risk Level:	L - Low Risk
Manufacturer:	Record RSS	Surface:	Wet Pour

Finding: There are a number of dents in the slide surface		Action: Monitor for any further deterioration and repair as required

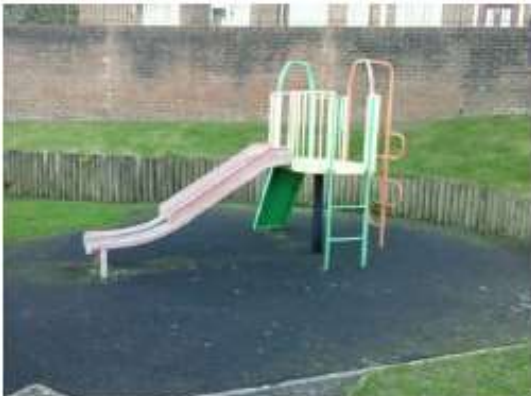
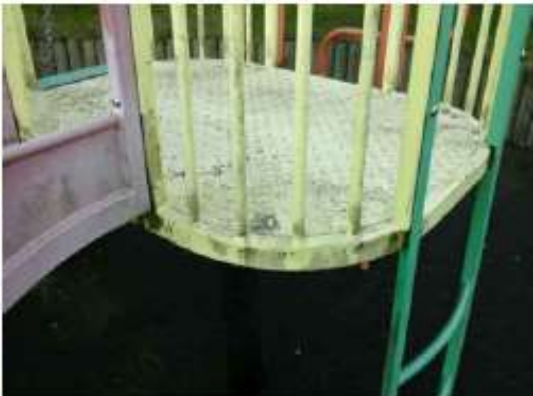
8 - Low Risk (Finding 2)			
Item:	Activity Equipment - Multi Play (Junior)	Risk Level:	L - Low Risk
Manufacturer:	Record RSS	Surface:	Wet Pour

Finding: There is algae or moss on the surface of the equipment		Action: Clean and treat appropriately

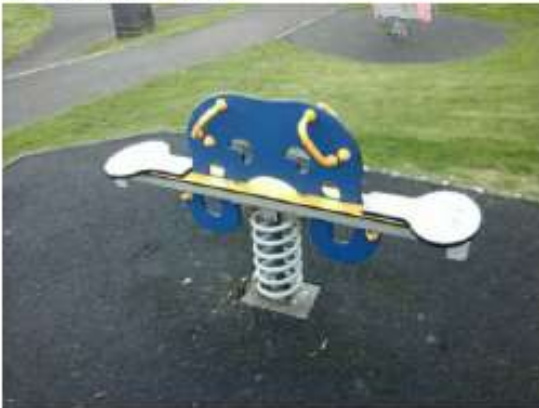
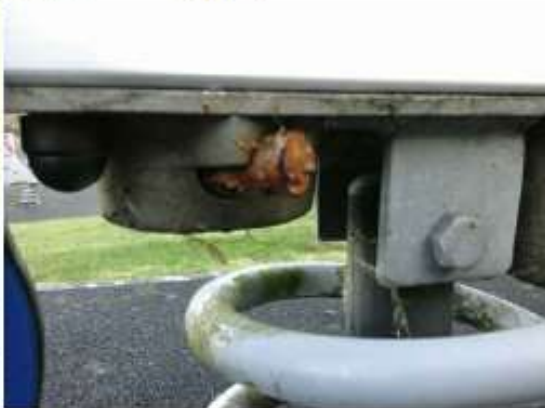
6 - Low Risk (Finding 2)			
Item:	Rocking Equipment - Spring See-Saw	Risk Level:	L - Low Risk
Manufacturer:	Ledon	Surface:	Wet Pour

Finding:	The paintwork on the spring has been damaged or worn exposing the metal underneath which is rusting		Action: Treat any rusting components and repaint

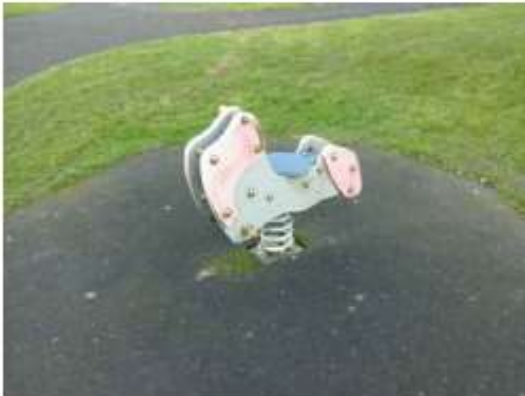
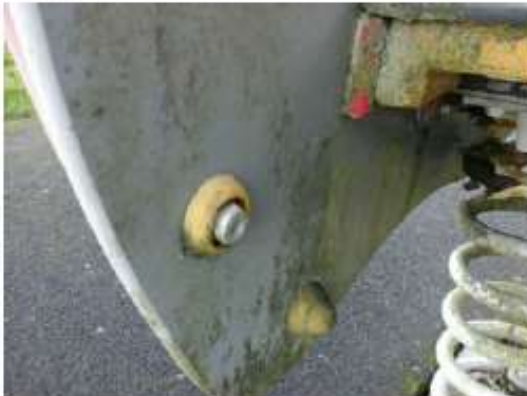
8 - Low Risk (Finding 3)			
Item:	Rocking Equipment - Misc Springer	Risk Level:	L - Low Risk
Manufacturer:	Ledon	Surface:	Wet Pour

Finding:	There is/are bolt cap covers missing or damaged on the item		Action: Replace missing or damaged bolt cap covers

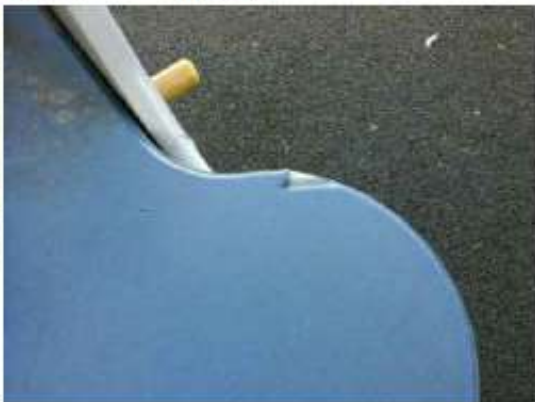
6 - Low Risk (Finding 4)			
Item:	Rocking Equipment - Misc Springer	Risk Level:	L - Low Risk
Manufacturer:	Ledon	Surface:	Wet Pour

Finding: There is minor damage to the seat		Action: Remove any sharp edges and monitor for any further deterioration and repair as required

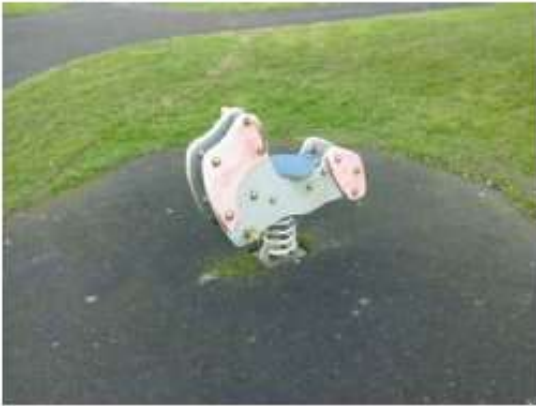
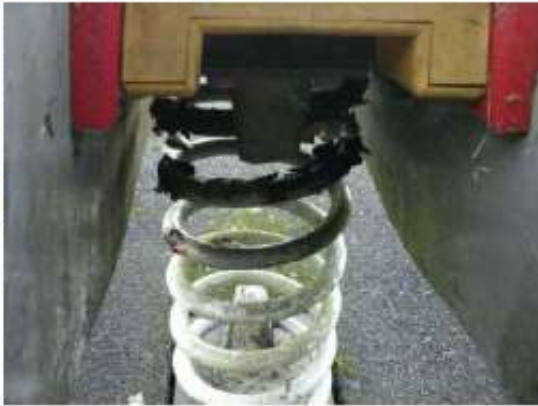
8 - Low Risk (Finding 8)

Item:	Rocking Equipment - Misc Springer	Risk Level:	L - Low Risk
Manufacturer:	Ledon	Surface:	Wet Pour

Finding: The paintwork on the spring has been damaged or worn exposing the metal underneath which is rusting

Action: Treat any rusting components and repaint

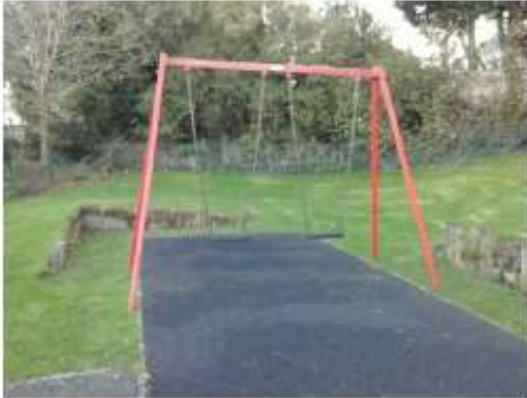
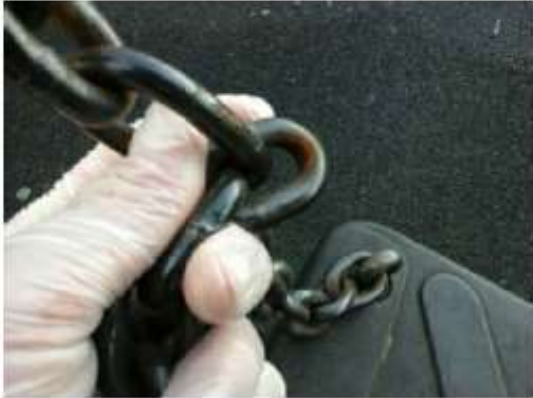
6 - Low Risk (Finding 3)			
Item:	Swings - 1 Bay 2 Seat (Flat)	Risk Level:	L - Low Risk
Manufacturer:	Record RSS	Surface:	Wet Pour

Finding: There is some chain wear		Action: Monitor for any further deterioration and replace when 40% worn

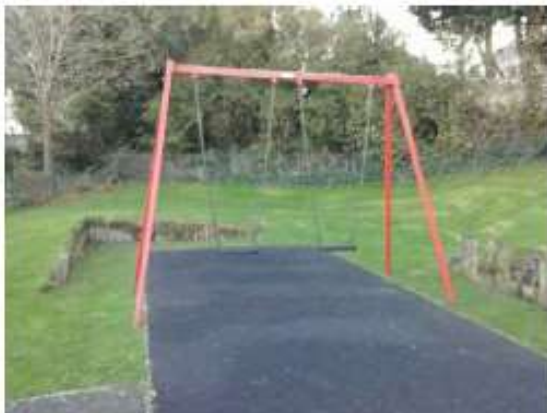
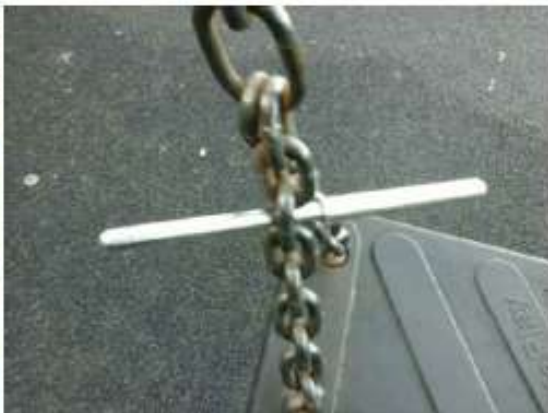
4 - Very Low Risk (Finding 4)			
Item:	Swings - 1 Bay 2 Seat (Flat)	Risk Level:	V - Very Low Risk
Manufacturer:	Record RSS	Surface:	Wet Pour

Finding:	The chain openings are in excess of the 8.6mm as recommended by BS EN 1176		Action:
			Monitor use and replace with compliant chains during next maintenance cycle.

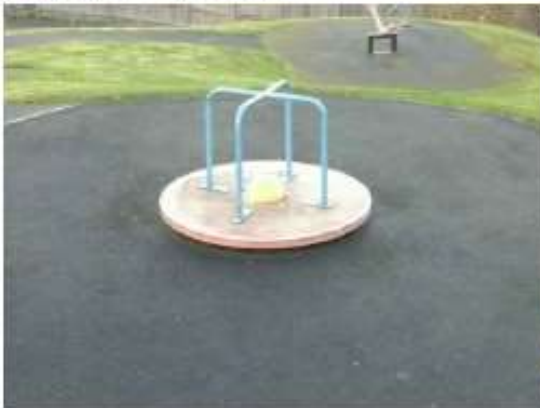
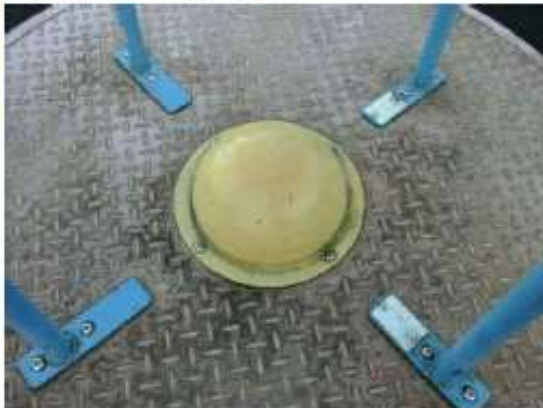
8 - Low Risk (Finding 1)			
Item:	Rotor Play - Roundabout	Risk Level:	L - Low Risk
Manufacturer:	Record RSS	Surface:	Wet Pour

Finding: The bearing on the unit is dry and stiff		Action: Service and lubricate the bearing(s)

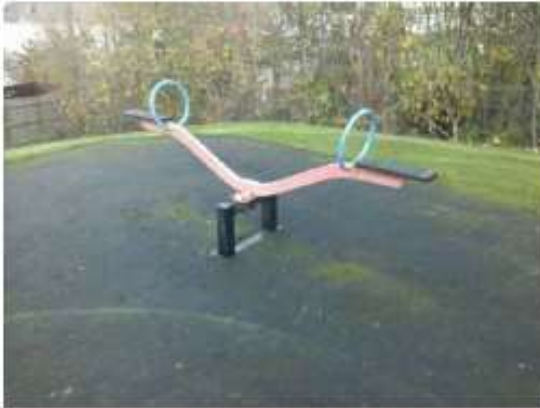
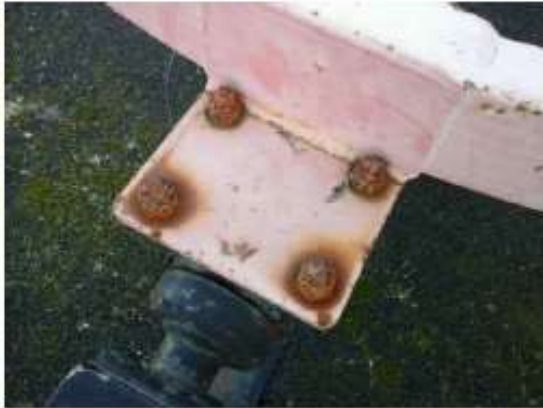
8 - Low Risk (Finding 1)			
Item:	Rocking Equipment - See Saw	Risk Level:	L - Low Risk
Manufacturer:	Record RSS	Surface:	Wet Pour

Finding: The mounting fixings are corroded		Action: Replace all affected fixings
