Services Committee - Budget Report - February 2018

Annual Inspection

Barratt Homes

Kernow Gate/Ashton Way
Saltash, Cornwall, PL12 6JE

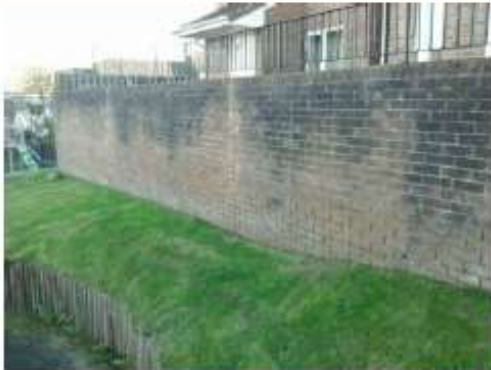
i 3 - Very Low Risk	
Item:	Ancillary Items - Brick Wall
Manufacturer:	Unknown
Surface Type:	Grass
Equipment Compliance:	N/A
Surface Area Compliance:	N/A
Ref/Part Number:	
Total Findings:	1

Finding 1
This item is satisfactory - no work required

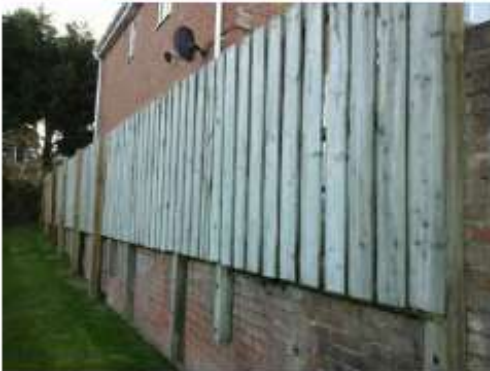
3 - Very Low Risk	
Item:	Ancillary Items - Fencing - Timber
Manufacturer:	Unknown
Surface Type:	Grass
Equipment Compliance:	N/A
Surface Area Compliance:	N/A
Ref/Part Number:	
Total Findings:	1

Finding 1
This item is satisfactory - no work required

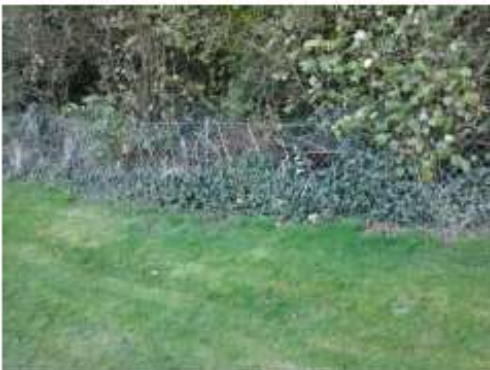
8 - Low Risk	
Item:	Ancillary Items - Fence - Chainlink
Manufacturer:	Unknown
Surface Type:	Grass
Equipment Compliance:	N/A
Surface Area Compliance:	N/A
Ref/Part Number:	
Total Findings:	3

Finding 1	Finding 2
The fence is damaged and there is an informal access to the site - Repair the fence to prevent access	There are a number of loose posts around the fence - Monitor for any further deterioration and reset as required

Finding 3
There is surface corrosion present on the posts - Consider treating and repainting the item

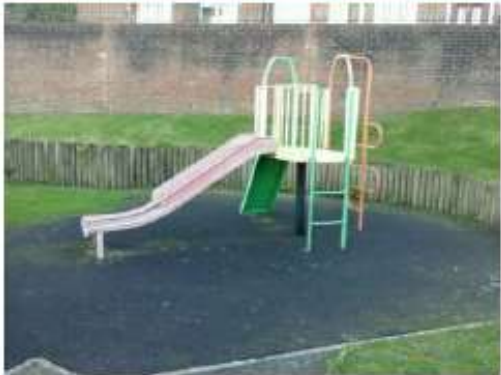
i 8 - Low Risk	
Item:	Activity Equipment - Multi Play (Junior)
Manufacturer:	Record RSS
Surface Type:	Wet Pour
Equipment Compliance:	No
Surface Area Compliance:	Yes
Ref/Part Number:	
Total Findings:	5

Finding 1 There are a number of dents in the slide surface - Monitor for any further deterioration and repair as required	Finding 2 There is algae or moss on the surface of the equipment - Clean and treat appropriately
Finding 3 The chain openings are in excess of the 8.6mm as recommended by BS EN 1176 - Monitor use and replace with compliant chains during next maintenance cycle.	Finding 4 There is/are finger entrapment/s in the top of the slide and the item fails to meet the requirements of BS EN 1176:2008 Part 1 4.2.7.8 Entrapment of fingers - Monitor use
Finding 5 There is surface corrosion present on the item - Consider treating and repainting the item

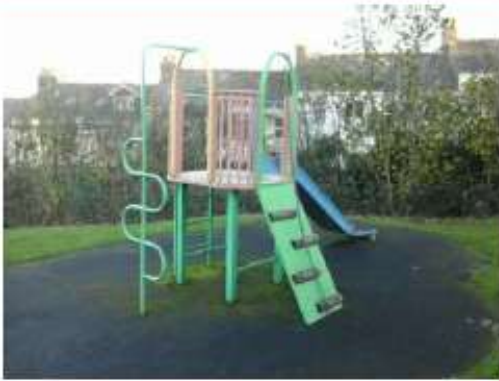
i 8 - Low Risk	
Item:	Activity Equipment - Multi Play (Junior)
Manufacturer:	Record RSS
Surface Type:	Wet Pour
Equipment Compliance:	Yes
Surface Area Compliance:	Yes
Ref/Part Number:	
Total Findings:	6

Finding 1 There are a number of dents in the slide surface - Monitor for any further deterioration and repair as required	Finding 2 There is algae or moss on the surface of the equipment - Clean and treat appropriately
Finding 3 There is surface corrosion present on the item - Consider treating and repainting the item	Finding 4 There is some graffiti present - Remove the graffiti
Finding 5 The climb post is slightly loose in its foundations - Monitor for any further deterioration and repair as required	Finding 6 The access ramp frame has corroded internally and blown - Monitor for any further deterioration in structural integrity and repair as required

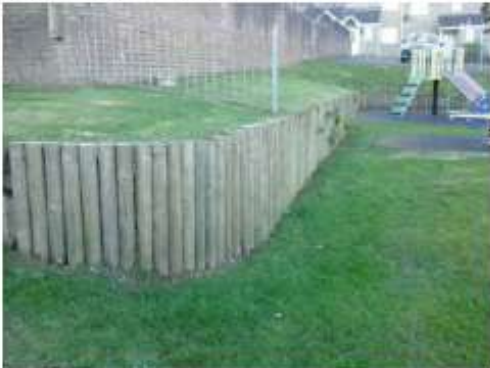
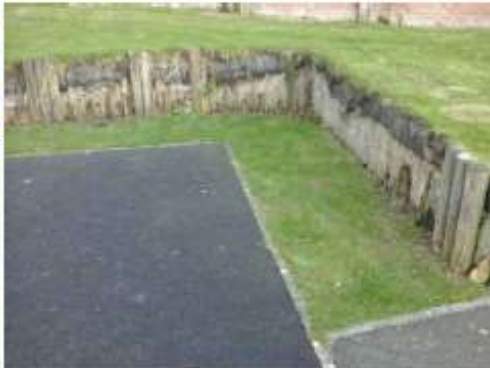
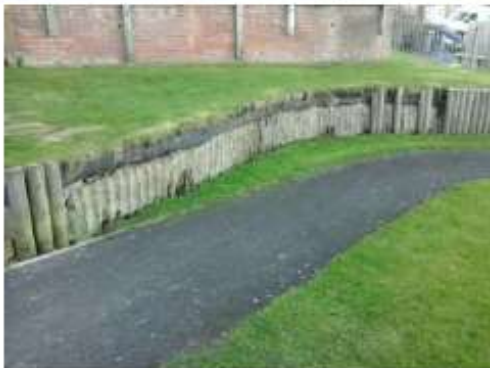
i 8 - Low Risk (Finding 1)			
Item:	Ancillary Items - Palisade Logs	Risk Level:	L - Low Risk
Manufacturer:	Unknown	Surface:	Grass

Finding:	There are a large number of logs missing from site		Action: Replace as required

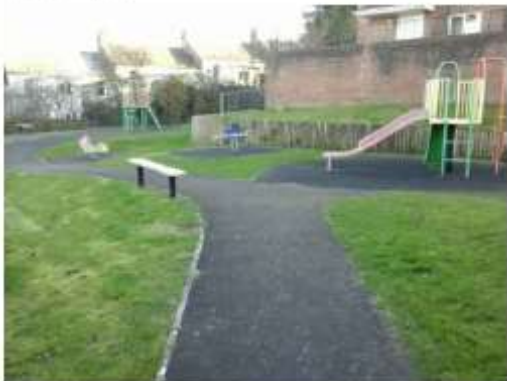
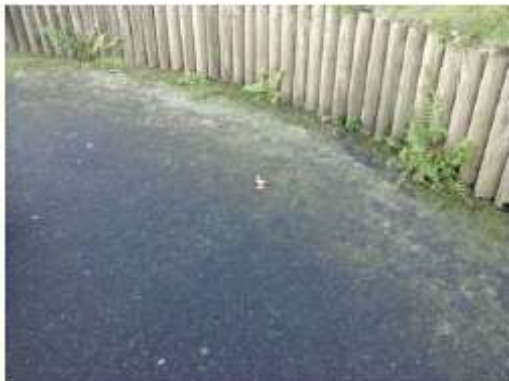
8 - Low Risk (Finding 2)			
Item:	Ancillary Items - Site General	Risk Level:	L - Low Risk
Manufacturer:	Unknown	Surface:	Grass

Finding: There is algae or moss growth on the wetpour surfaces throughout the site resulting in slippery conditions		Action: Clean and treat appropriately

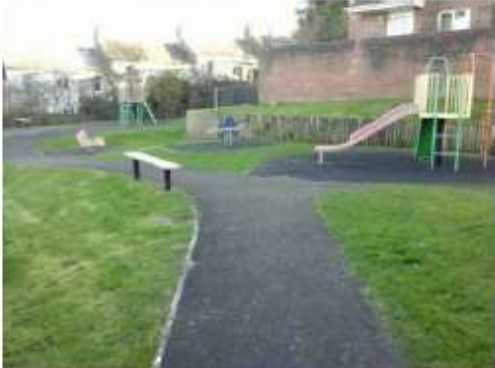
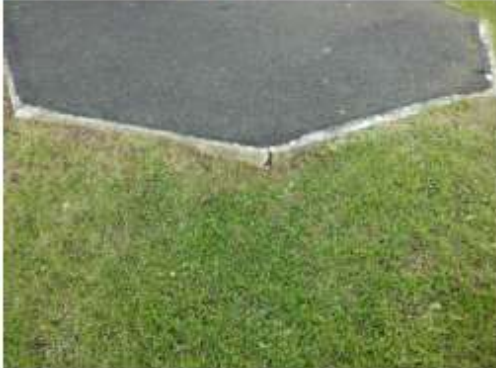
8 - Low Risk (Finding 3)			
Item:	Ancillary Items - Site General	Risk Level:	L - Low Risk
Manufacturer:	Unknown	Surface:	Grass

Finding:	There are trip hazards at the edges of the surfaces throughout the site		Action:
		Reinstate surrounding surface levels to remove the trip points

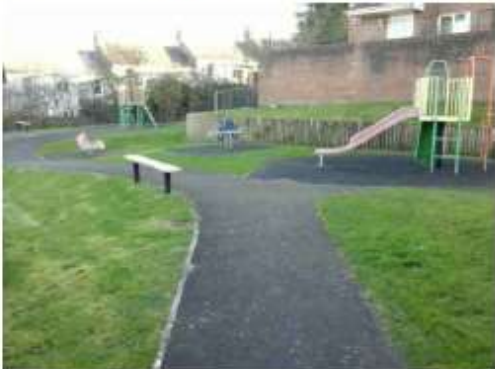
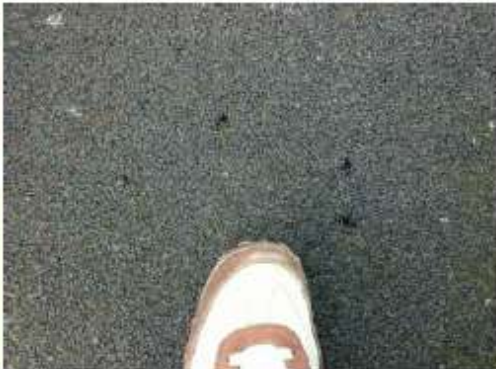
6 - Low Risk (Finding 4)			
Item:	Ancillary Items - Site General	Risk Level:	L - Low Risk
Manufacturer:	Unknown	Surface:	Grass

Finding:	The safety surfaces throughout the site are beginning to wear		Action:
		Monitor for any further deterioration and repair as required

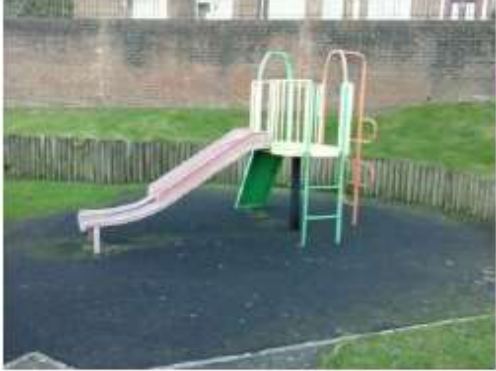
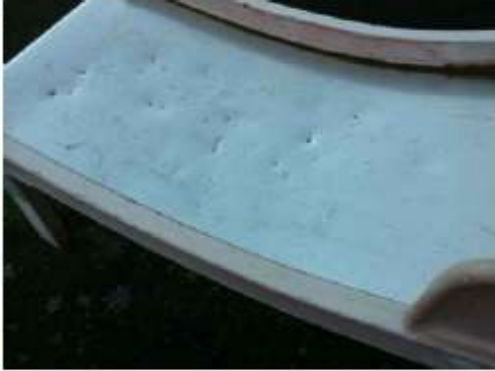
6 - Low Risk (Finding 1)			
Item:	Activity Equipment - Multi Play (Junior)	Risk Level:	L - Low Risk
Manufacturer:	Record RSS	Surface:	Wet Pour

Finding:	There are a number of dents in the slide surface		Action: Monitor for any further deterioration and repair as required

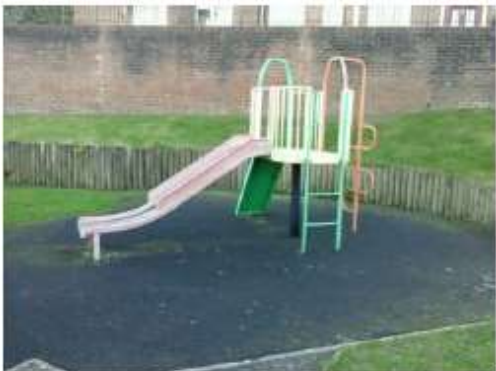
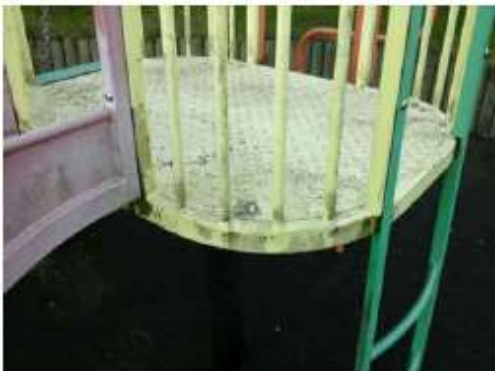
8 - Low Risk (Finding 2)			
Item:	Activity Equipment - Multi Play (Junior)	Risk Level:	L - Low Risk
Manufacturer:	Record RSS	Surface:	Wet Pour

Finding:	There is algae or moss on the surface of the equipment		Action: Clean and treat appropriately

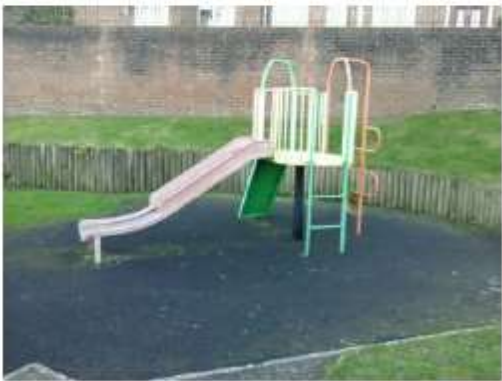
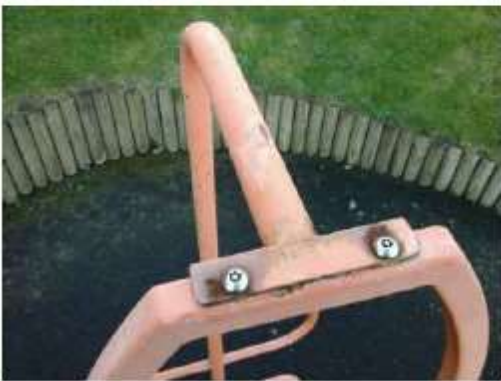
Item:	Activity Equipment - Multi Play (Junior)	Risk Level:	L - Low Risk
Manufacturer:	Record RSS	Surface:	Wet Pour

Finding: There is surface corrosion present on the item

Action: Consider treating and repainting the item

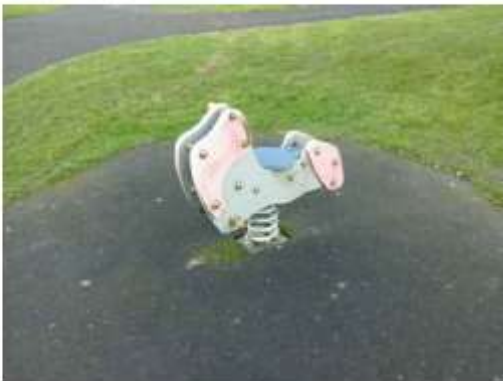
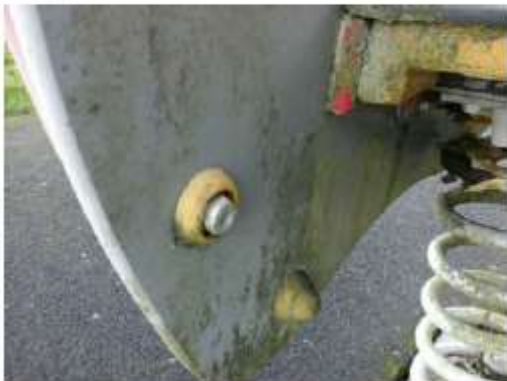
8 - Low Risk (Finding 3)			
Item:	Rocking Equipment - Misc Springer	Risk Level:	L - Low Risk
Manufacturer:	Ledon	Surface:	Wet Pour

Finding: There is/are bolt cap covers missing or damaged on the item		Action: Replace missing or damaged bolt cap covers

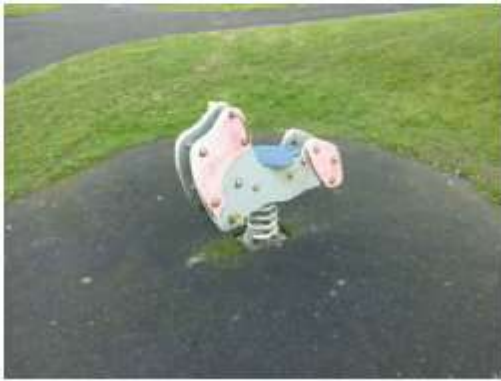
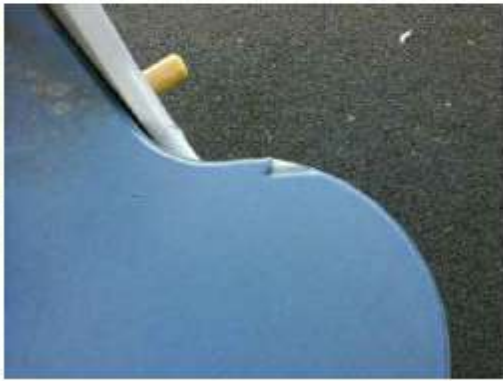
6 - Low Risk (Finding 4)			
Item:	Rocking Equipment - Misc Springer	Risk Level:	L - Low Risk
Manufacturer:	Ledon	Surface:	Wet Pour

Finding:	There is minor damage to the seat		Action: Remove any sharp edges and monitor for any further deterioration and repair as required

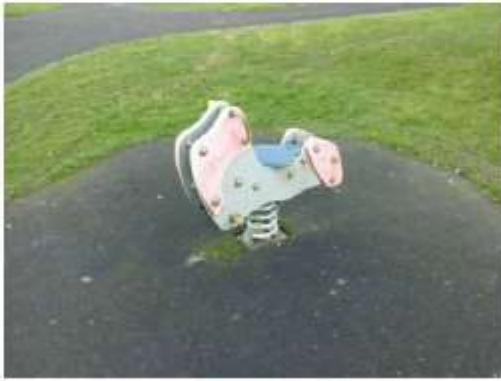
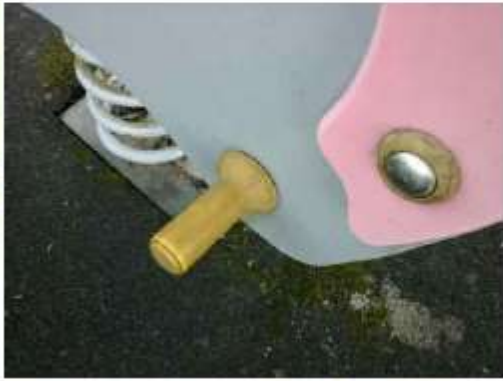
6 - Low Risk (Finding 5)			
Item:	Rocking Equipment - Misc Springer	Risk Level:	L - Low Risk
Manufacturer:	Ledon	Surface:	Wet Pour

Finding:	The Handgrips/Footrests rotate and may cause an unexpected movement for the user		Action: Secure Handgrips/Footrests to prevent rotation.

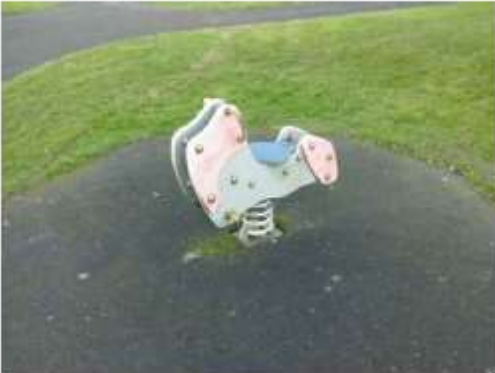
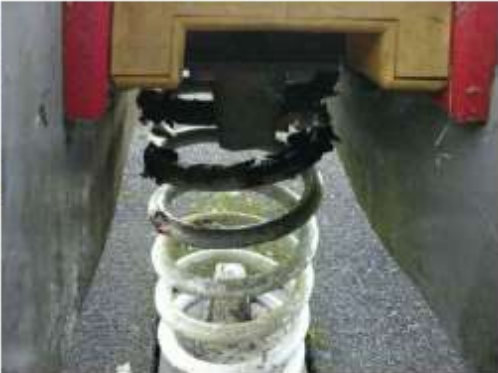
6 - Low Risk (Finding 6)			
Item:	Rocking Equipment - Misc Springer	Risk Level:	L - Low Risk
Manufacturer:	Ledon	Surface:	Wet Pour

Finding:	The paintwork on the spring has been damaged or worn exposing the metal underneath which is rusting		
Action:	Treat any rusting components and repaint

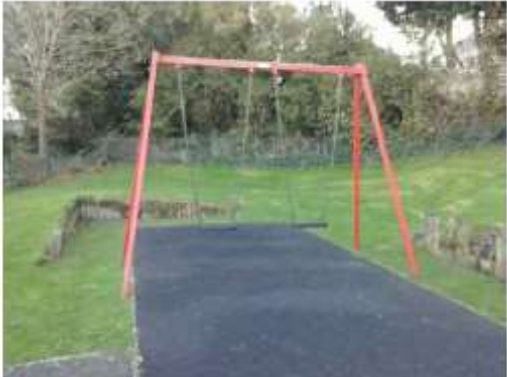
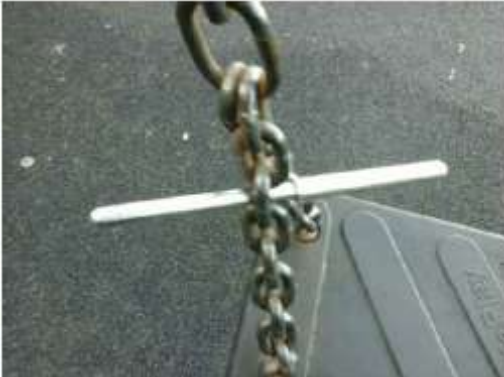
4 - Very Low Risk (Finding 4)			
Item:	Swings - 1 Bay 2 Seat (Flat)	Risk Level:	V - Very Low Risk
Manufacturer:	Record RSS	Surface:	Wet Pour

Finding: The chain openings are in excess of the 8.6mm as recommended by BS EN 1176		Action: Monitor use and replace with compliant chains during next maintenance cycle.

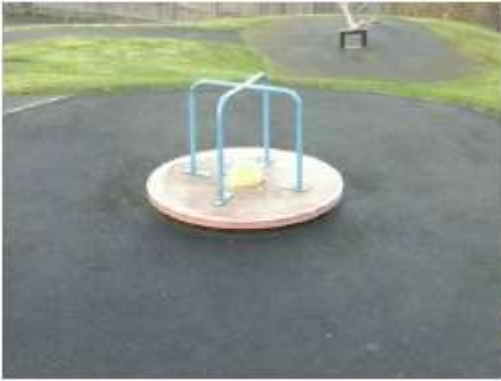
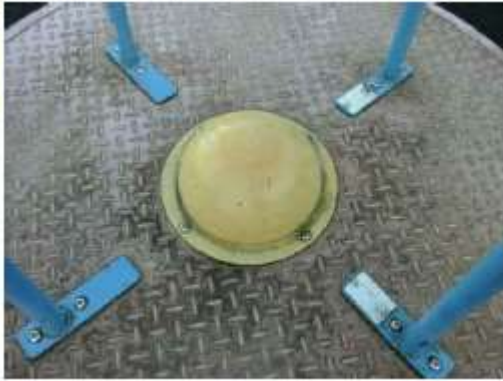
6 - Low Risk (Finding 1)			
Item:	Rotor Play - Roundabout	Risk Level:	L - Low Risk
Manufacturer:	Record RSS	Surface:	Wet Pour

Finding: The bearing on the unit is dry and stiff		Action: Service and lubricate the bearing(s)

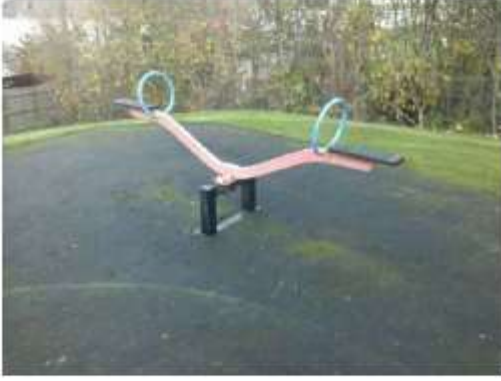
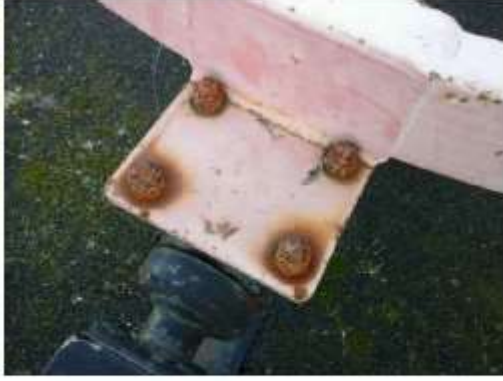
8 - Low Risk (Finding 1)			
Item:	Rocking Equipment - See Saw	Risk Level:	L - Low Risk
Manufacturer:	Record RSS	Surface:	Wet Pour

Finding: The mounting fixings are corroded		Action: Replace all affected fixings

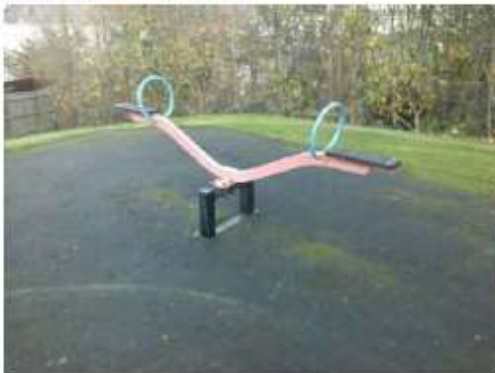
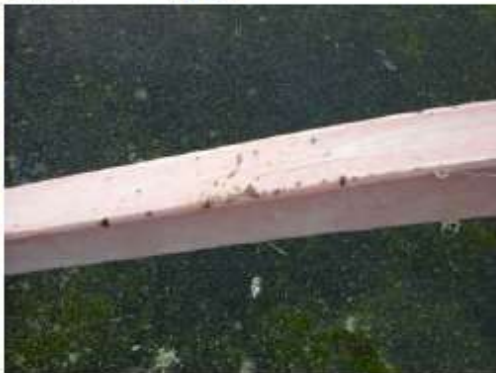
i 0 - Low Risk (Finding 3)			
Item:	Rocking Equipment - See Saw	Risk Level:	L - Low Risk
Manufacturer:	Record RSS	Surface:	Wet Pour

Finding: There is surface corrosion present on the item		Action: Consider treating and repainting the item
