## **BUILDING SURVEY REPORT**

**Victoria Gardens  
Callington Road  
Saltash  
PL12 4DL**

**Saltash Town Council  
The Guildhall  
Lower Fore Street  
Saltash  
PL12 6JX**

March 2018

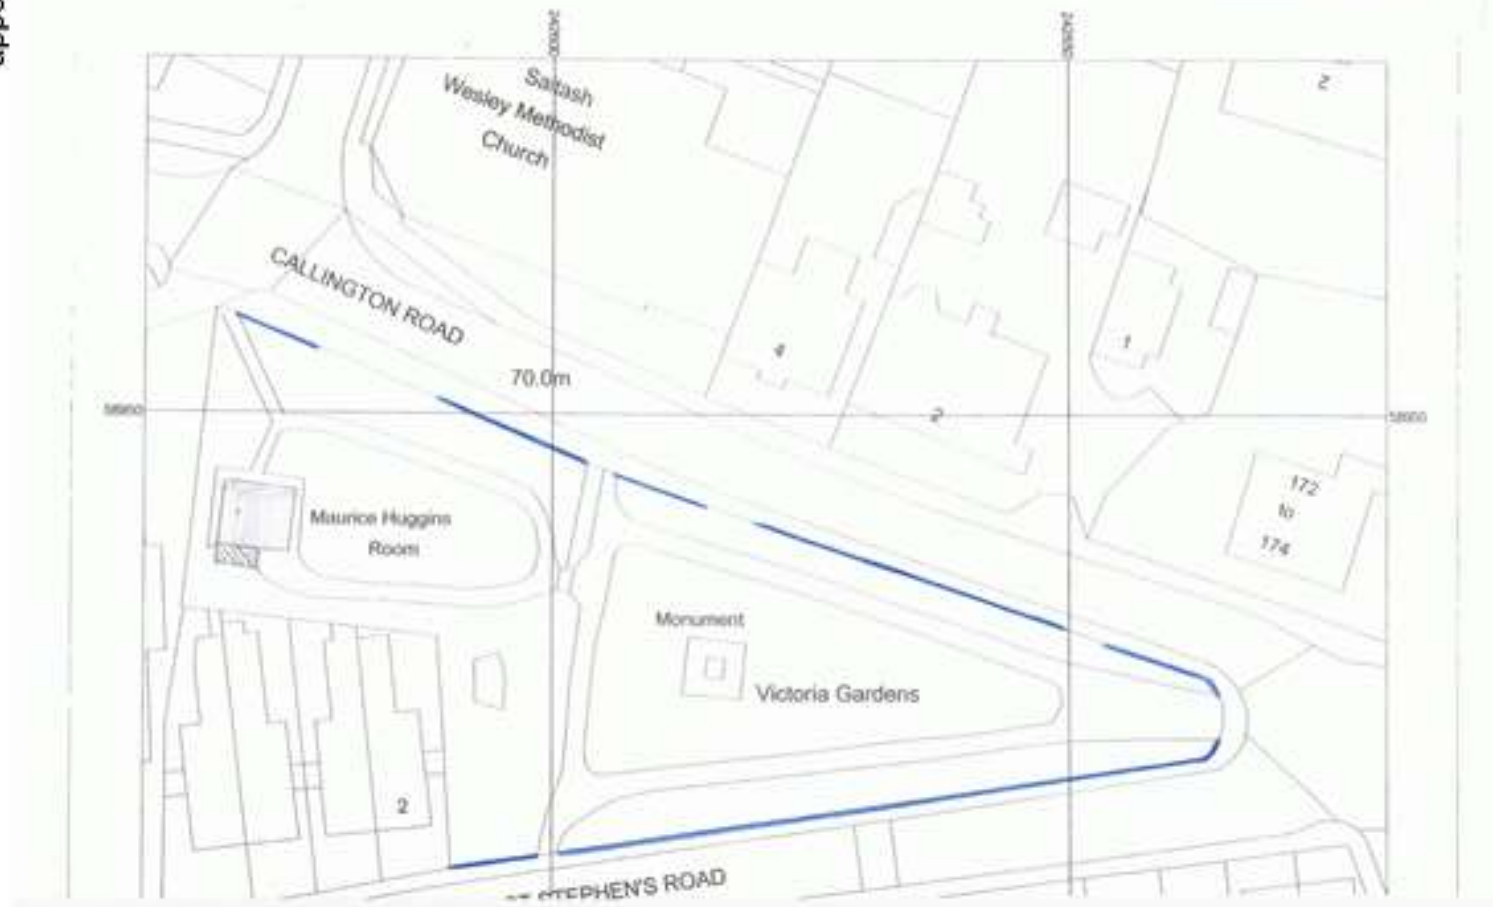
There are minor areas of pointing to various sections of the walls – see Appendix A – and these defects are encouraged by weed growth in the walls.

areas requiring re-pointing

I recommend that weeds be removed, defective areas of pointing raked out and the masonry re-pointed with a lime-based mortar.

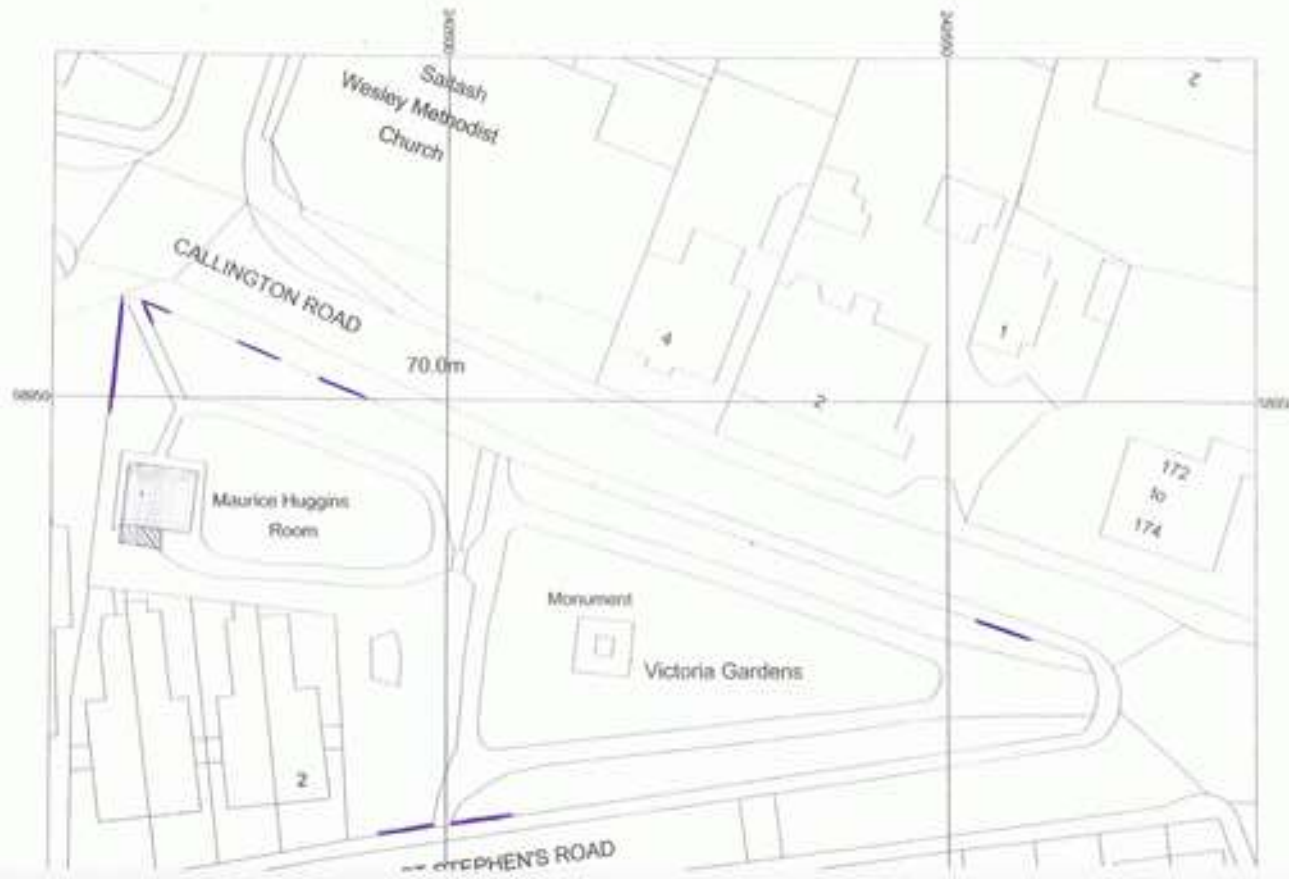
Appendix B

There are a number of areas where displacement of individual stones has taken place to masonry to the north boundary wall – see Appendix B.

This is most evidenced at the lower end of the north boundary where an *Araucaria Araucana* tree (commonly known as a 'Monkey Puzzle' tree) has been left to its own devices and has spread. These trees will grow to heights in excess of 12 metres with an 8 metre spread over a long period of time and it is likely that this particular specimen was planted when the Gardens were originally laid out.

There is evidence of settlement around the top gate off Callington Road and also some minor damage to the dwarf masonry walls leading towards the Maurice Huggins Room – see Appendix B. These areas require some very minor reconstruction work.

Towards the upper end of the south boundary the wall is out of plumb with the wall leaning towards the footpath by up to 5 degrees over the height of the wall - see appendix B. This movement has occurred over a long period of time and cannot be prevented from continuing unless the back of the wall is excavated, pressure removed, and the wall taken down and rebuilt incorporating drainage and weep holes. I do not, however, consider this to be a priority at this time especially as masonry is in sound condition but regular monitoring is advised and should the wall deteriorate or become unstable rebuilding will have to be considered.

displaced masonry

The displacement will continue if the tree is to stay in-situ. To prevent further deterioration of the wall, without removal of the tree, I suggest stainless steel strapping of the wall.

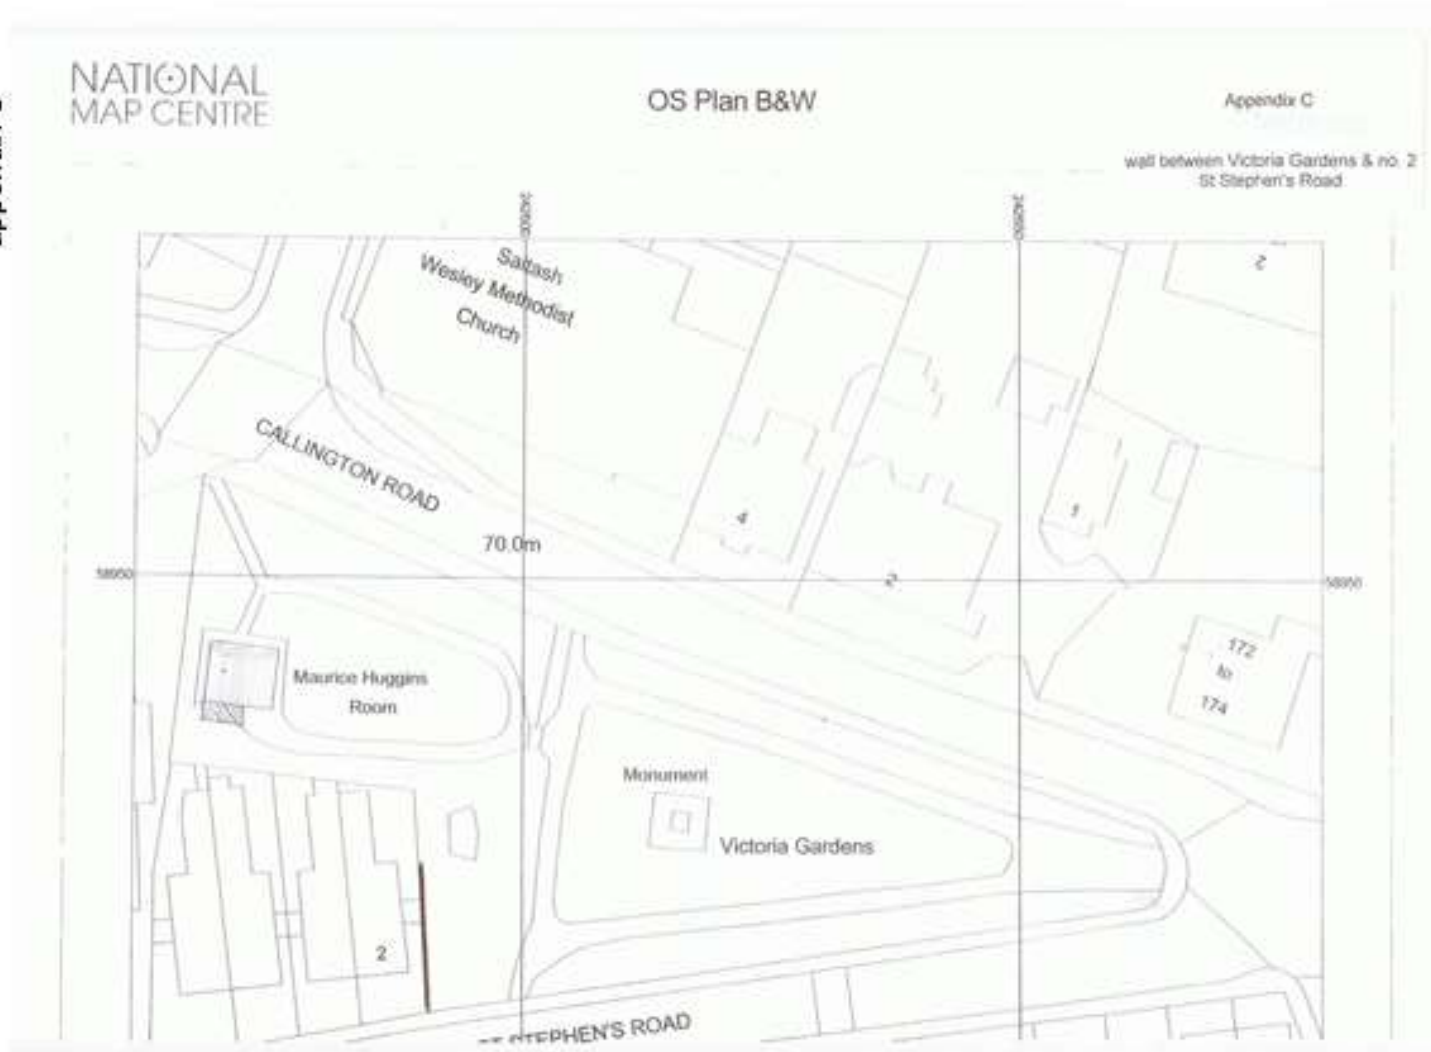
appendix C

The section of wall between Victoria Gardens and no 2 St Stephen's Road – see Appendix C – is covered in ivy and other vegetation and can only be seen clearly from the private garden to no. 2 St Stephen's Road. This is, in effect, a party structure between the Gardens and no. 2 St Stephen's Road. From the limited inspection possible the wall appears sound. There follows a length of hedge approximately 2m- 3m in front of the wall comprising a mix of shrubs but primarily *Salix*, *Bay*, *Blackthorn* and *Ivy* see appendix D

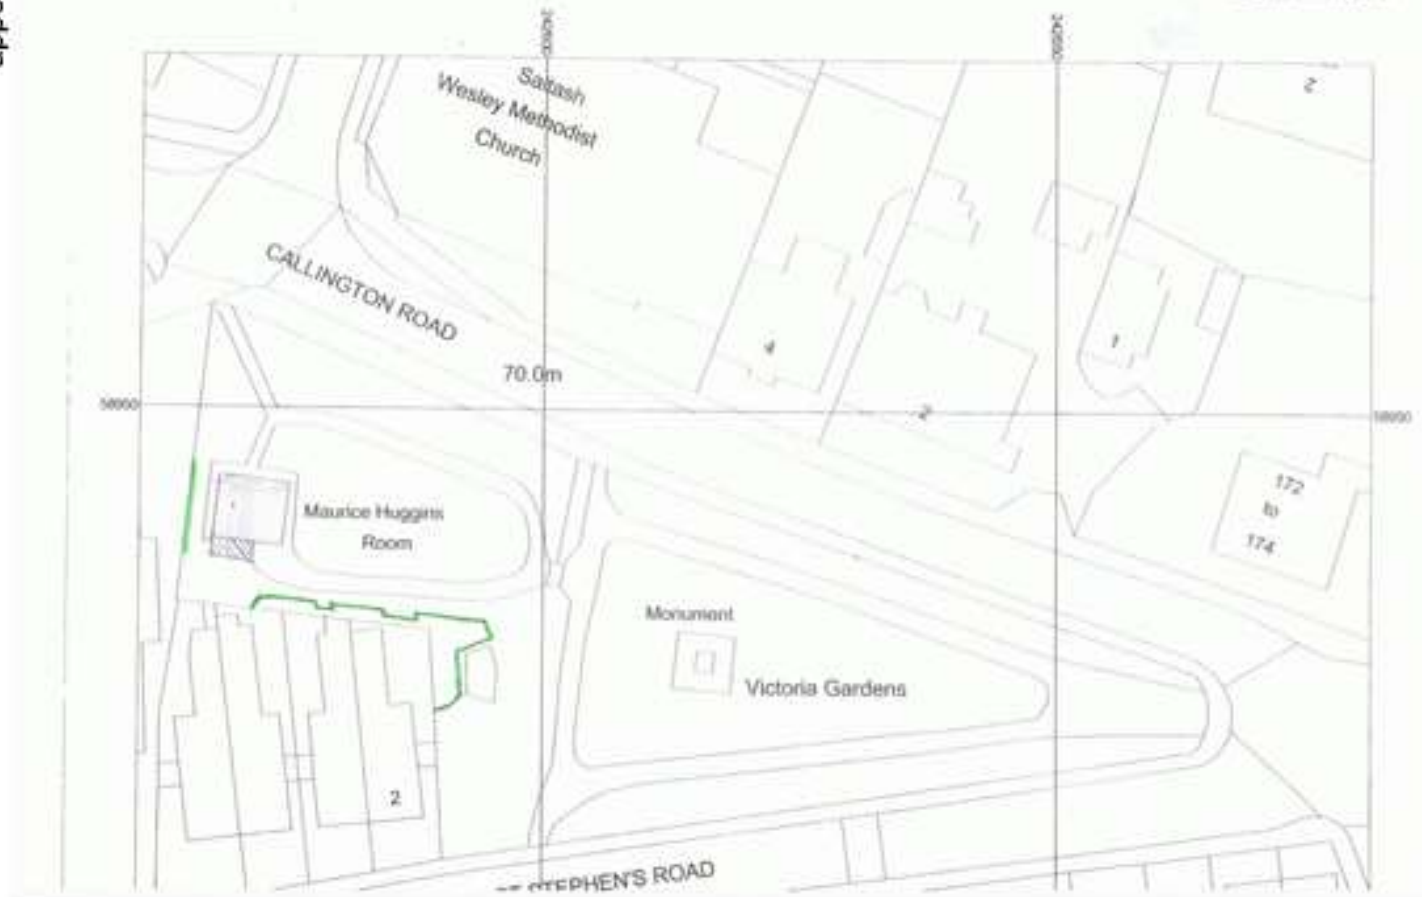
Appendix D

lengths of hedgerow

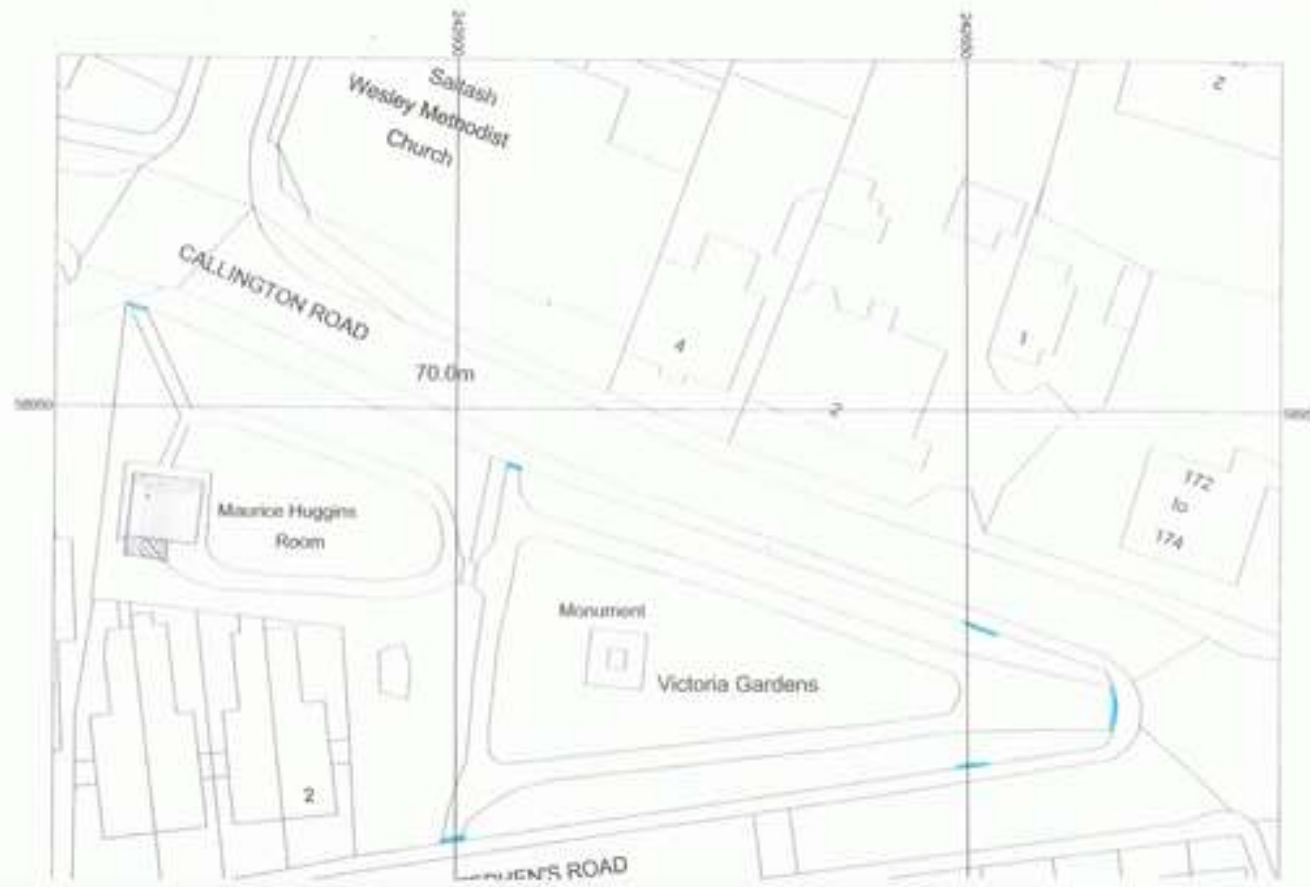
Appendix E

There are, however, some parts of the balustrade where severe corrosion has taken place and repairs/replacement are required – see positions on Appendix E.

defective metal work

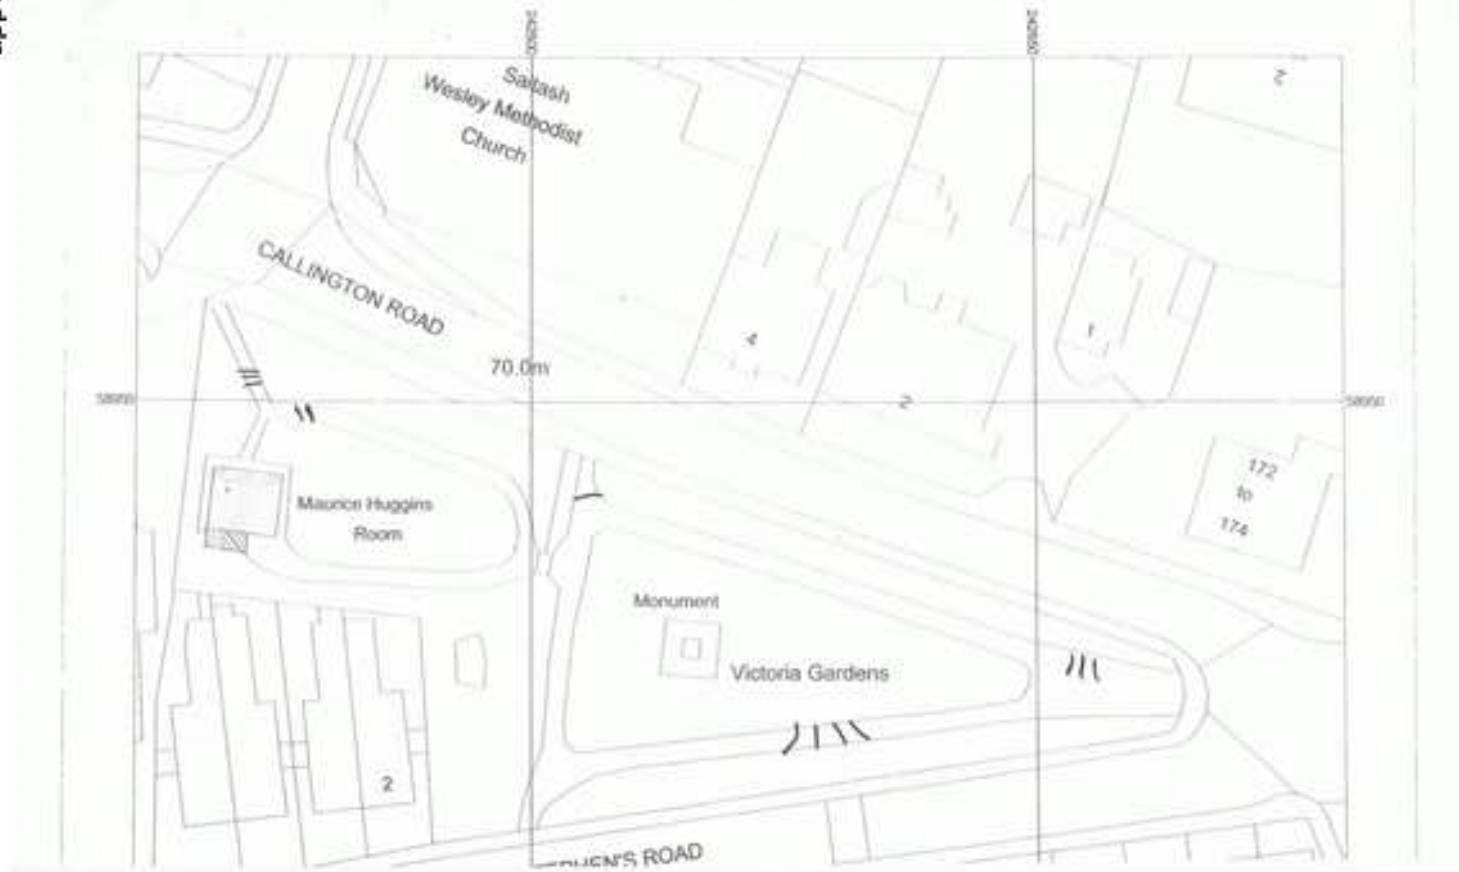
Pathways are primarily finished with tarmac, although there are some minor areas of concrete, and generally are in reasonable condition. Exceptions are shown on Appendix F and these areas have been damaged because of tree roots. These areas require taking up and relaying.

damage to footpaths

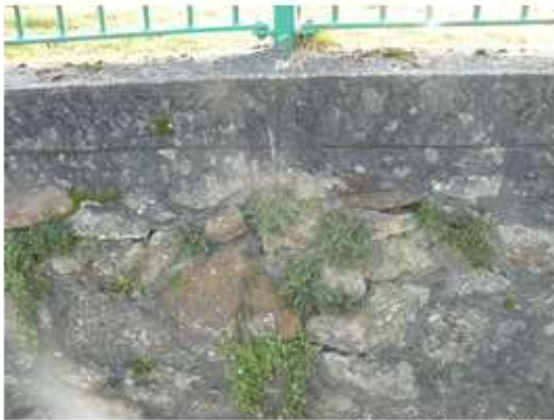
example of weed growth & defective pointing

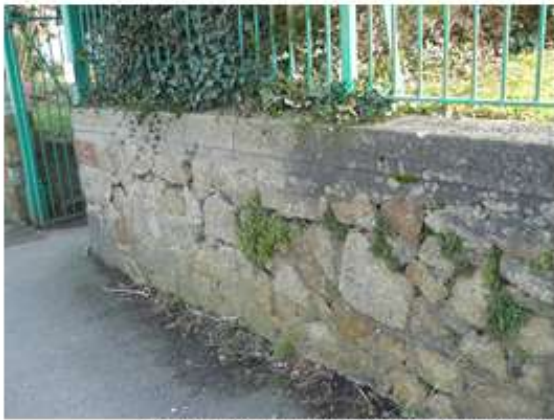
example of weed growth & defective pointing

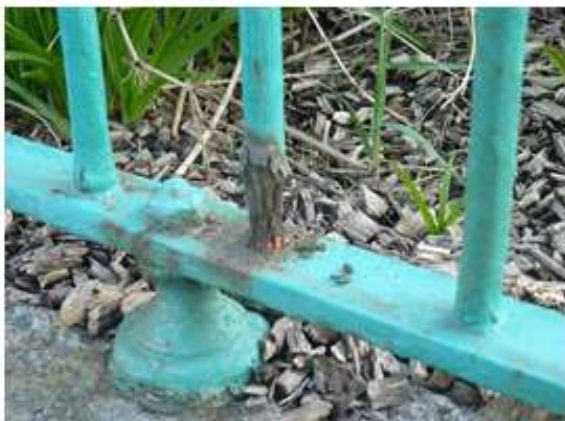
example of corrosion to metal railings

I recommend a complete preparation and redecoration of the balustrade.

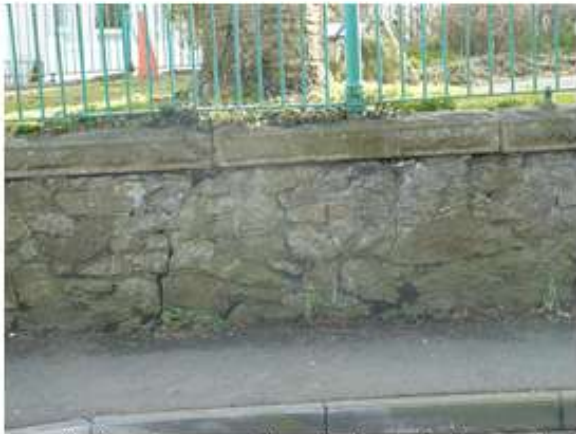
displaced masonry adjacent to *Araucaria Araucana* tree

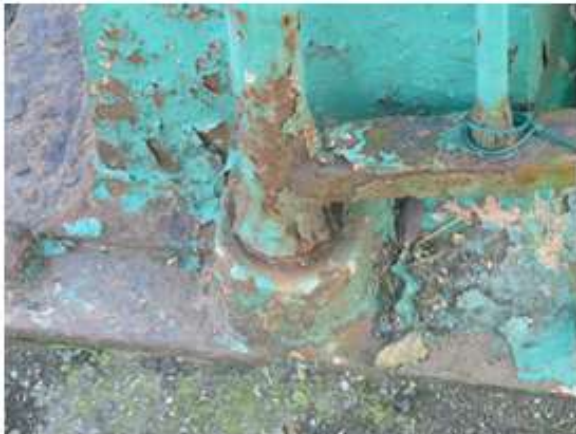
corrosion to east gate

Remaining entrance gates all require some minor adjustment. The decorative condition is the same as the railings and I recommend a full preparation and redecoration of all areas.

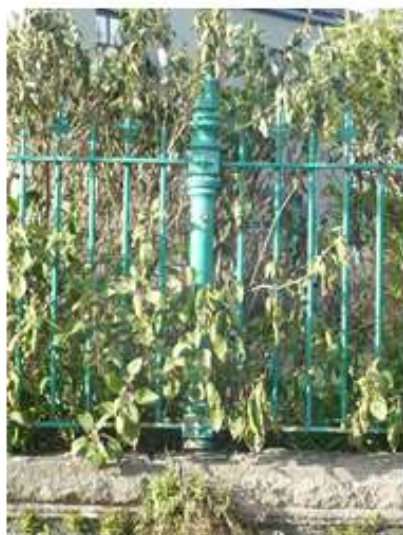
corroded newel post on southern boundary

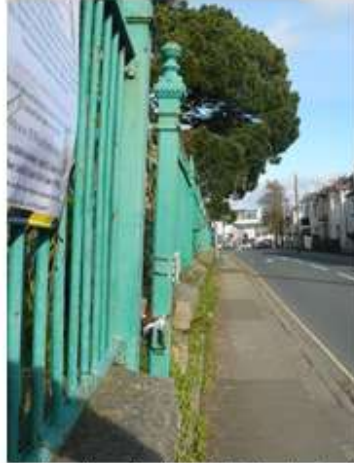
railing and wall leaning into St Stephen's Road

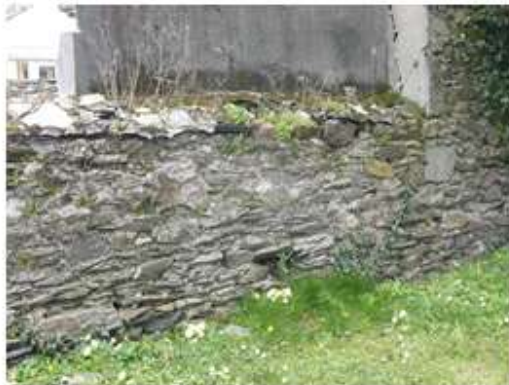
From the rear of no. 8 St Stephen's Road the wall then turns another 90 degrees and becomes a party structure between Victoria Gardens and Malvern House. This is also of random-coursed solid masonry and forms a retaining wall for Victoria Gardens. Behind the Maurice Huggins Room the wall is hidden by hedgerow, similar to that on other boundaries, but the masonry is exposed to the north of the Maurice Huggins Room as far as the north boundary to the Gardens.

wall between Victoria Gardens and Malvern House

Here the wall is generally poor with loose stones and copings and I recommend all loose stones and copings be removed and parts of the wall be rebuilt to match the existing.

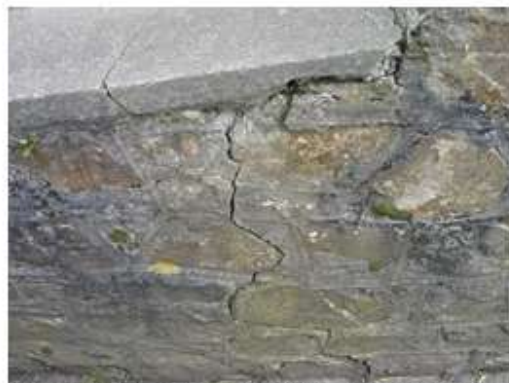
settlement of wall adjacent to higher Callington Road entrance

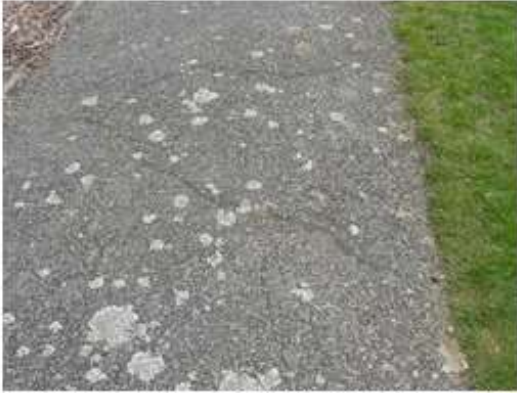
displaced tarmac adjacent to *Araucaria Araucana* tree

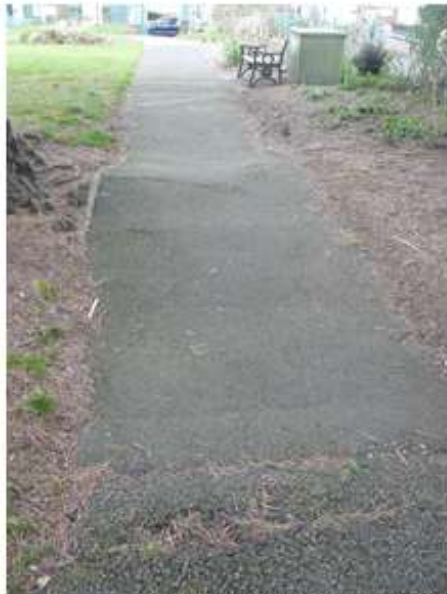
displaced tarmac adjacent to fir tree
