**report regarding condition of and repairs to the
roof at :**

Saltash Library

following storm damage over the weekend

Saltash Town Council

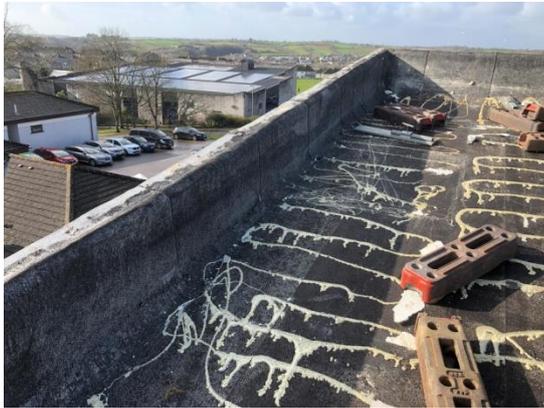
The roof is divided into a number of areas and the main damage was done to the south westerly bay and associated parapets. The edge trims had been damaged and wind, still at considerable strength, had got under the roof covering and was lifting it in a number of places. It was clear to both me and Simon Kalis of Stormforce that the way to deal with the problem and to minimise further damage to both the roof and surrounding areas was to strip the sw bay completely and any other minor defects to adjacent areas, carefully remove remaining insulation to that particular bay, and remove damaged edge trim.

The library is a relatively exposed and vulnerable building in the locality especially the south west corner of the building. This is the area of the roof that was damaged and my conclusion is that the extreme weather was the cause of the damage and, presumably, is insurable.

south west bay to roof following strip back of damaged roofing material, insulation and edge trim

When roof covering of this type is laid it forms a single sheet of material over the whole of the roof and is weakened should 'raw' edges be exposed to wind and rain and so following further conversations with Stormforce it was considered prudent to recover the roof and secure new edge trims, as soon as safely possible to do so.

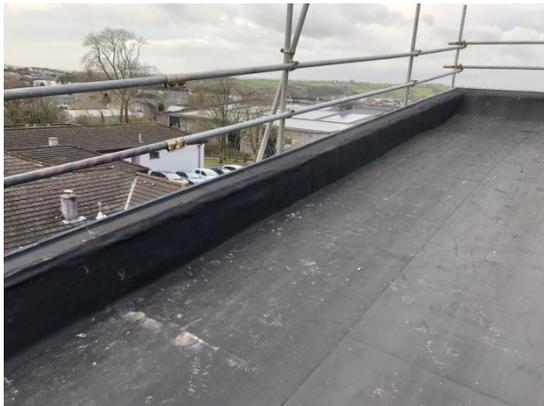
south west bay to roof following strip back of damaged roofing material, insulation and edge trim

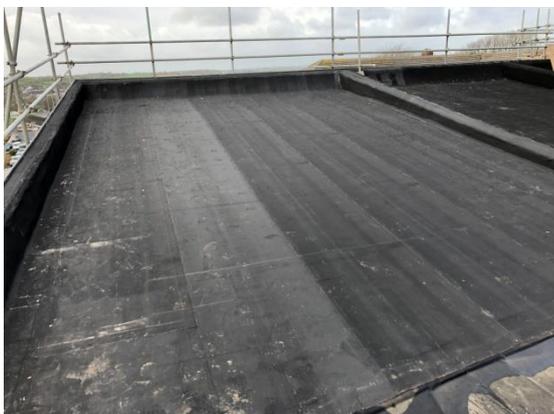
south west bay to roof following strip back of damaged roofing material, insulation and edge trim
