Services Committee - Budget Report - February 2018

Annual Inspection

Barratt Homes

Kernow Gate/Ashton Way
Saltash, Cornwall, PL12 6JE

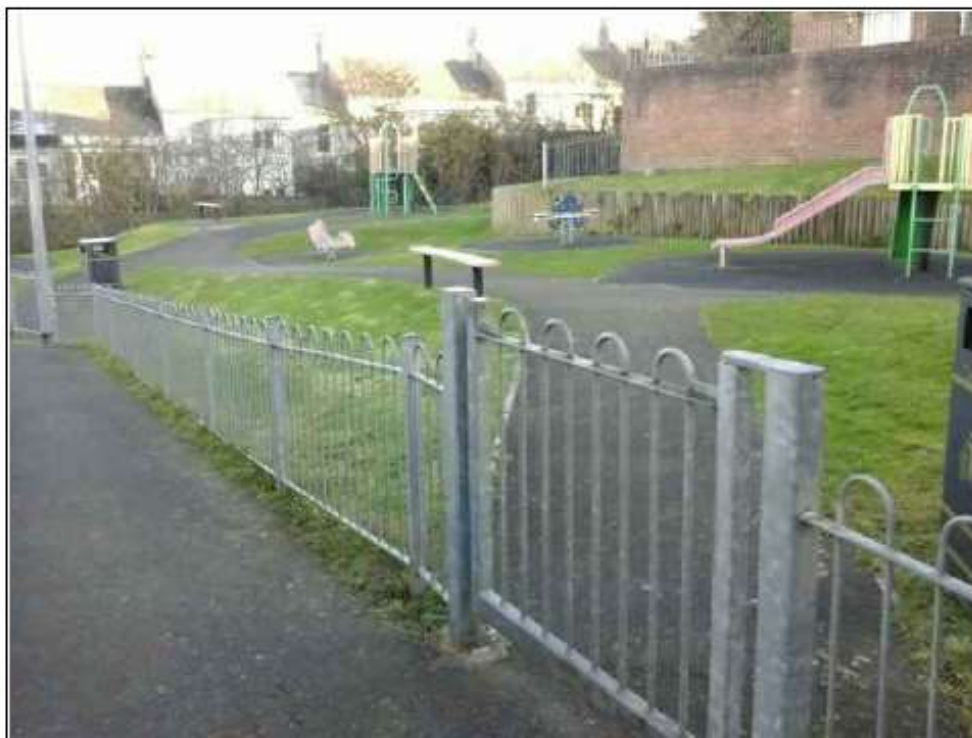
Risk Assessment: 8 - Low Risk

Location: The site is located in an area of public open space and is overlooked by a number of properties in the local community.

Disabled Access: Generally accessible; an area accessible to most but not all people even when help is at hand.
